Field Survey of Tsunami Effects in Sri Lanka due to the Sumatra-Andaman Earthquake of December 26, 2004

Abstract—The December 26, 2004 Sumatra-Andaman earthquake that registered a moment magnitude (M_w) of 9.1 was one of the largest earthquakes in the world since 1900. The devastating tsunami that resulted from this earthquake caused more casualties than any previously reported tsunami. The number of fatalities and missing persons in the most seriously affected countries were Indonesia - 167,736, Sri Lanka - 35,322, India - 18,045 and Thailand - 8,212. This paper describes two field visits to assess tsunami effects in Sri Lanka by a combined team of Japanese and Sri Lankan researchers. The first field visit from December 30, 2004 – January 04, 2005 covered the western and southern coasts of Sri Lanka including the cities of Moratuwa, Beruwala, Bentota, Pereliya, Hikkaduwa, Galle, Talpe, Matara, Tangalla and Hambantota. The objectives of the first field visit were to investigate the damage caused by the tsunami and to obtain eyewitness information about wave arrival times. The second field visit from March 10–18, 2005 covered the eastern and southern coasts of Sri Lanka and include

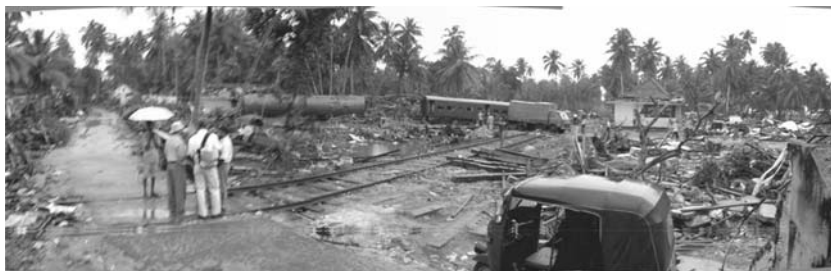
Figure 3

Pereliya: Though this area is about 200 m from the coast, an express train was washed away by the tsunami and about 1,000 people lost their lives.

This paper describes two field visits to assess tsunami effects in Sri Lanka by a combined team of Japanese and Sri Lankan researchers. The field visit routes and main cities covered by the field visits are shown in Figure 2. The first field visit from December 30, 2004 – January 04, 2005 covered the western and southern coasts of Sri Lanka and included the cities of Moratuwa, Beruwala, Bentota, Pereliya, Hikkaduwa, Galle, Talpe, Matara, Tangalla, and Hambantota. The objectives of the first field visit were to investigate the damage caused by the tsunami and to obtain eyewitness information about wave arrival times. One of the most tragic events due to the tsunami occurred at Pereliya on the SW coast, where a train that was stopped between stations was swept off the rail tracks when the tsunami struck, and around 1,000 people are estimated to have lost their lives due to this incident (Fig. 3). Most

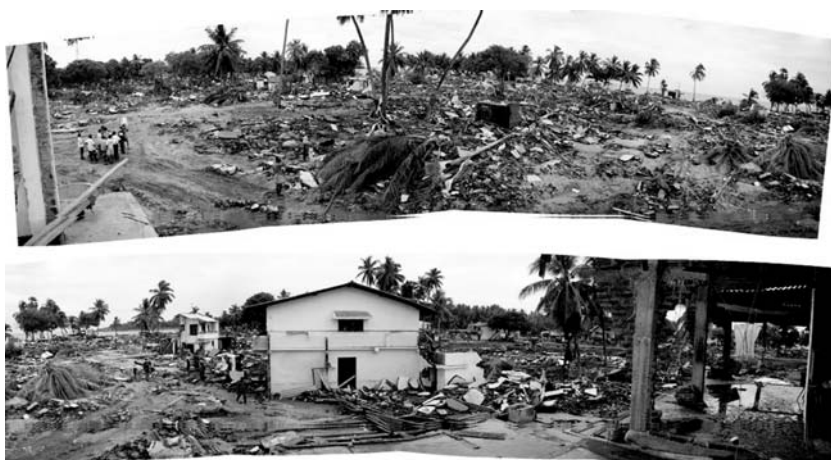
Hambantota: Masonry houses located within a few hundred meters from the coast were completely destroyed, a few more recently constructed houses had less damage.

of the low-cost masonry houses located in the coastal region were completely destroyed, while two story-buildings with concrete columns and beams sustained less damage. Figure 4 shows destroyed masonry houses near the Hambantota coast. More photographs of tsunami damage taken during the first field visit are given in WIJEYEWICKREMA *et al.* (2005). The second field visit from March 10–18, 2005 covered the NE, east, SE and south Sri Lanka and included Trincomalee, Kuchchaveli, Batticaloa, Arugam Bay, Yala National Park, and Kirinda. Some photographs taken during the second field visit are given in WIJEYEWICKREMA *et al.* (2006). The objectives of the second visit were mainly to obtain eyewitness information about wave arrival times and inundation data, and to take relevant measurements using GPS instruments.

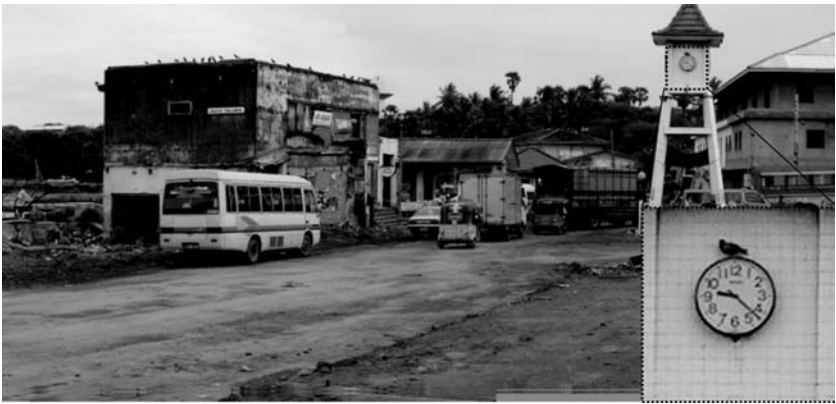
Figure 6
A broken clock close to the main bus station in Hambantota indicates 09:22. The Hambantota bay is on the left.

- (b) Time recorded on the clock tower located close to the Hambantota main bus station (Fig. 6). The clock had stopped due to the wave action at 09:22 and this time corresponds to the arrival time of the maximum wave according to an eyewitness who reported that the first wave was the biggest wave among the waves that attacked this area and the second wave was at 09:35.
